PROPERTY CONDITION ASSESSMENT
OF
WORLD TRADE CENTER PORTFOLIO

ONE WORLD TRADE CENTER

Merritt & Harris, Inc. Project Number 20-251E

December 6, 2000

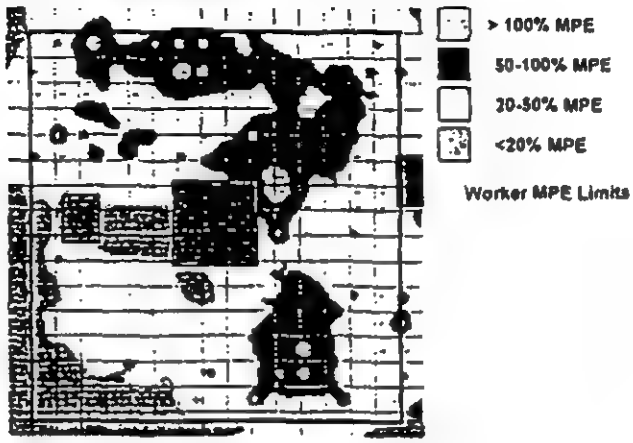
An Obvious Practical Insight from the Roof RF Survey Results

RF field levels around the edge are the weakest.

Using a walking path around the perimeter of the roof to avoid strong RF fields.

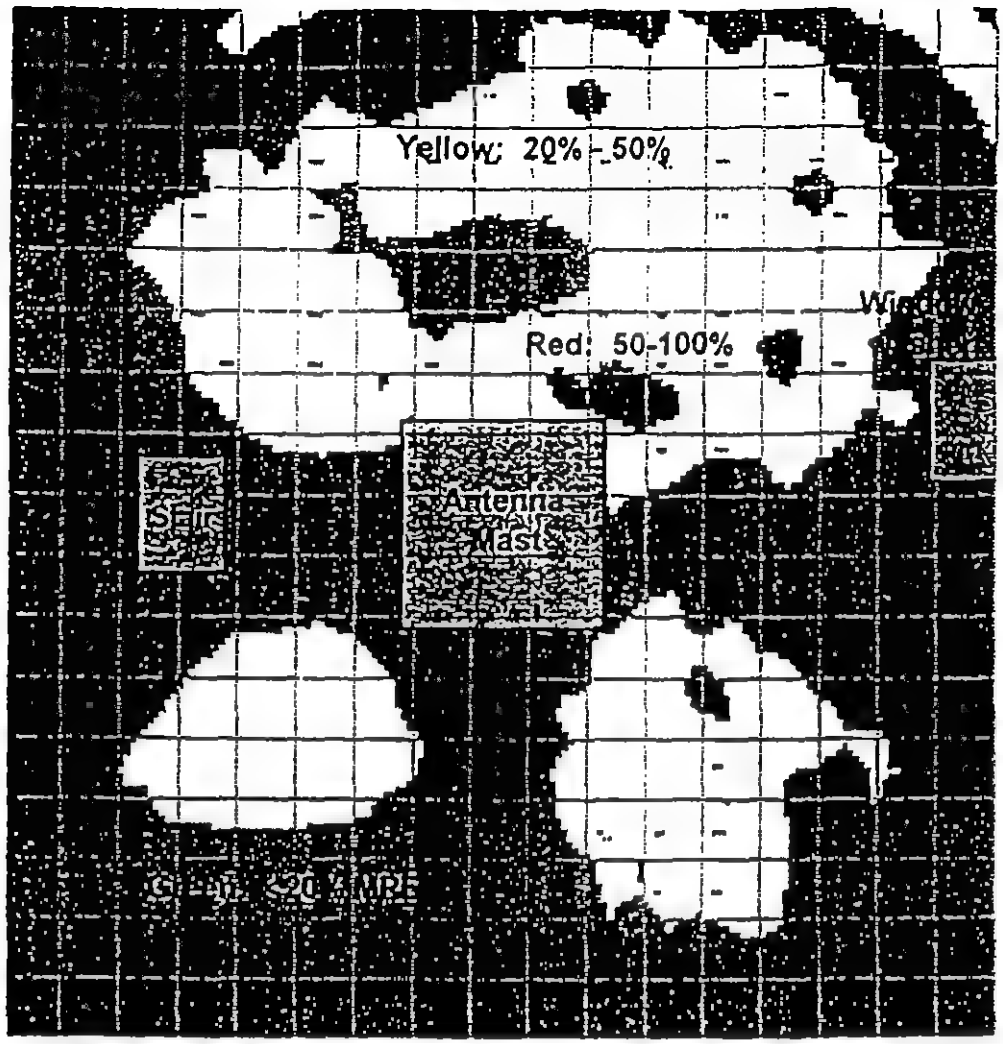
Figure 6. Roof map showing measured ambient RF fields on roof of north tower of World Trade Center during normal broadcast operations with contributions from 72 MHz paging links included Maximum field is 70 2% MPE

Statistical summary of RF Fields on WTC roof (see Figure 6)		
Percent occupational MPE range (%)	Roof area in this range (ft^2)	Percent of roof area in this range (%)
0-20	17070	62.75
21-50	9778	35 94
51-100	350	1 31
>100	0	0 00

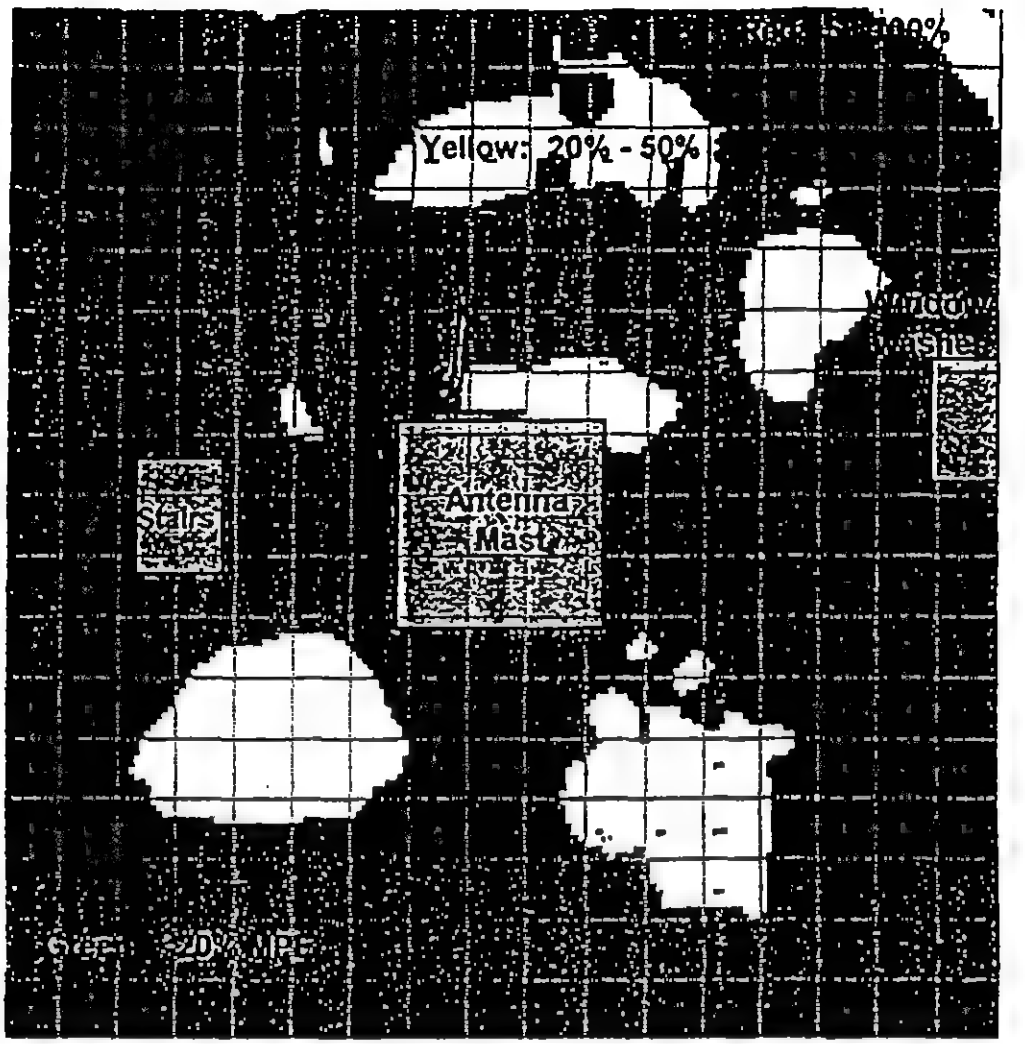
Figure 8. Roof map of normal broadcast ambient RF fields with contribution of 72 MHz paging links removed via analysis with RoofView. Maximum field is 56.6% MPE.

Statistical summary of RF Fields on WTC roof (see Figure 8)		
Percent occupational MPE range (%)	Roof area in this range (ft^2)	Percent of roof area in this range (%)
0-20	23262	85 51
21-50	3937	14 47
51-100	6	0 02
>100	0	0 00

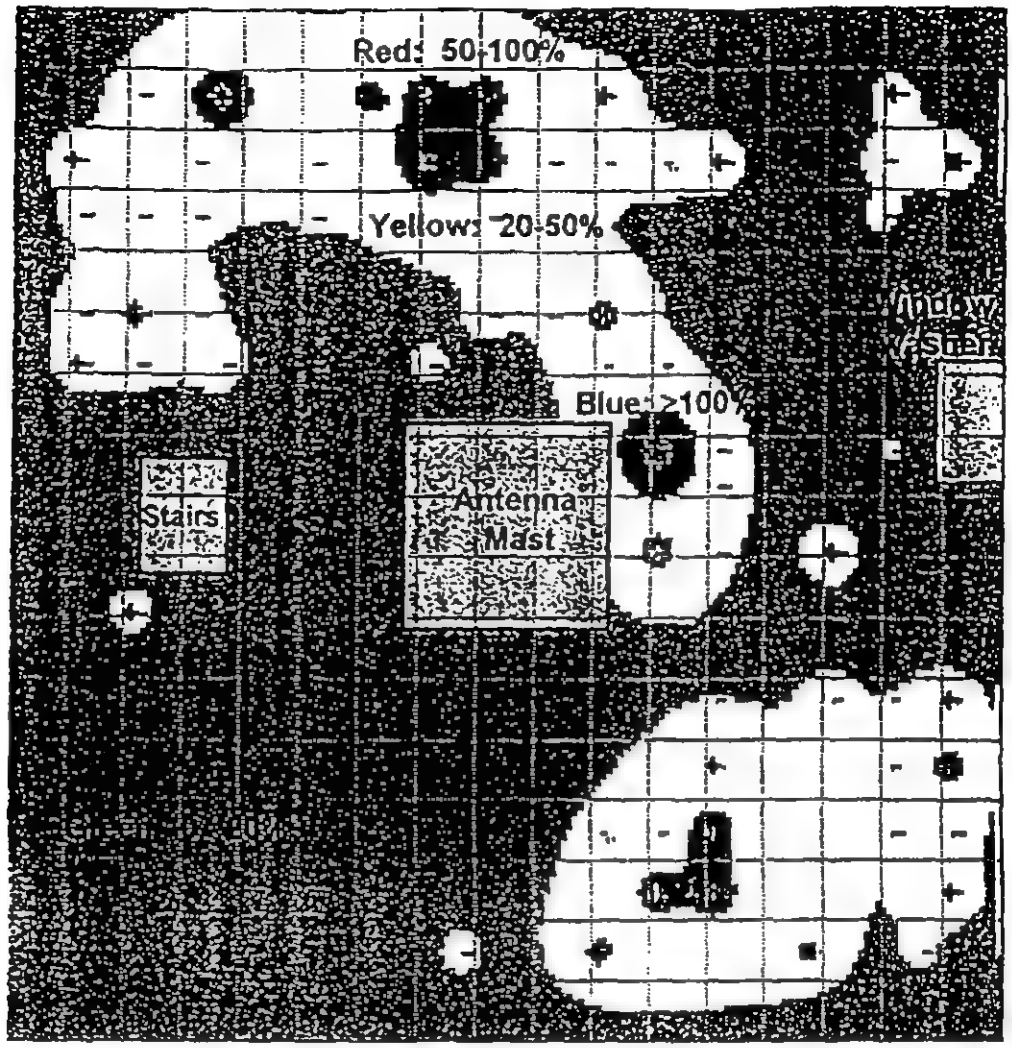
Figure 19. RoofView computed roof map for all wireless telecommunications antennas assumed operating but without contribution of RF fields from any of 72 MHz paging links or any contribution from broadcasting facilities Maximum field is 273 9% MPE

Statistical summary of RF Fields on WTC roof (see Figure 19)		
Percent occupational MPE range (%)	Roof area in this range (ft^2)	Percent of roof area in this range (%)
0-20	17324	63 68
21-50	8960	32 94
51-100	833	3 06
>100	88	0 32

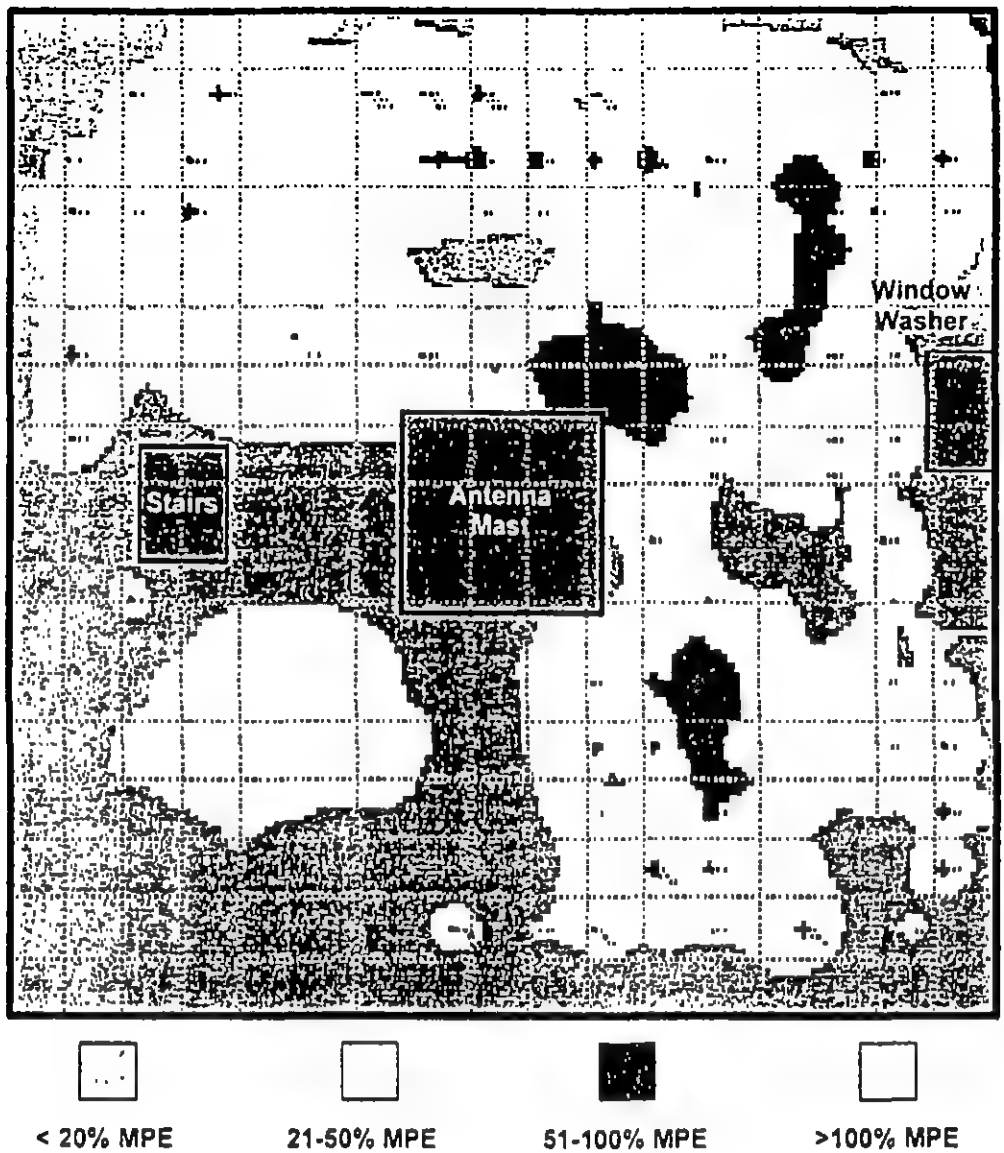
Figure 2. 1999 reevaluation of RF fields from measured ambient fields of normal broadcasting operations with calculated contribution of all wireless telecommunications antennas with selected antennas raised to eliminate fields exceeding MPE. Maximum field is 77.5% MPE.

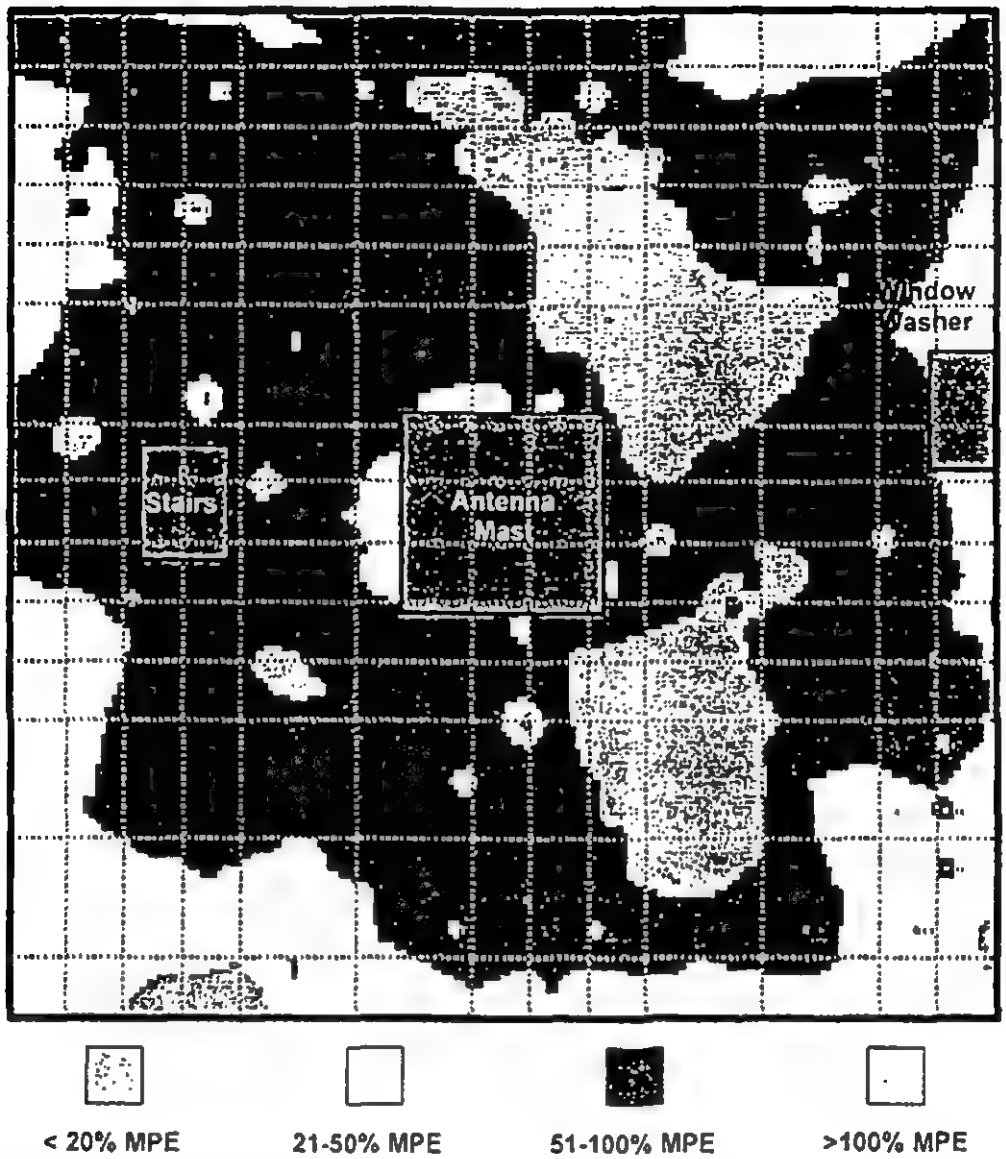
Figure 3. 1999 reanalysis of RF fields from measured ambient fields of tower maintenance broadcasting operations with calculated contribution of all wireless telecommunications antennas. Maximum field is 333.5% MPE.

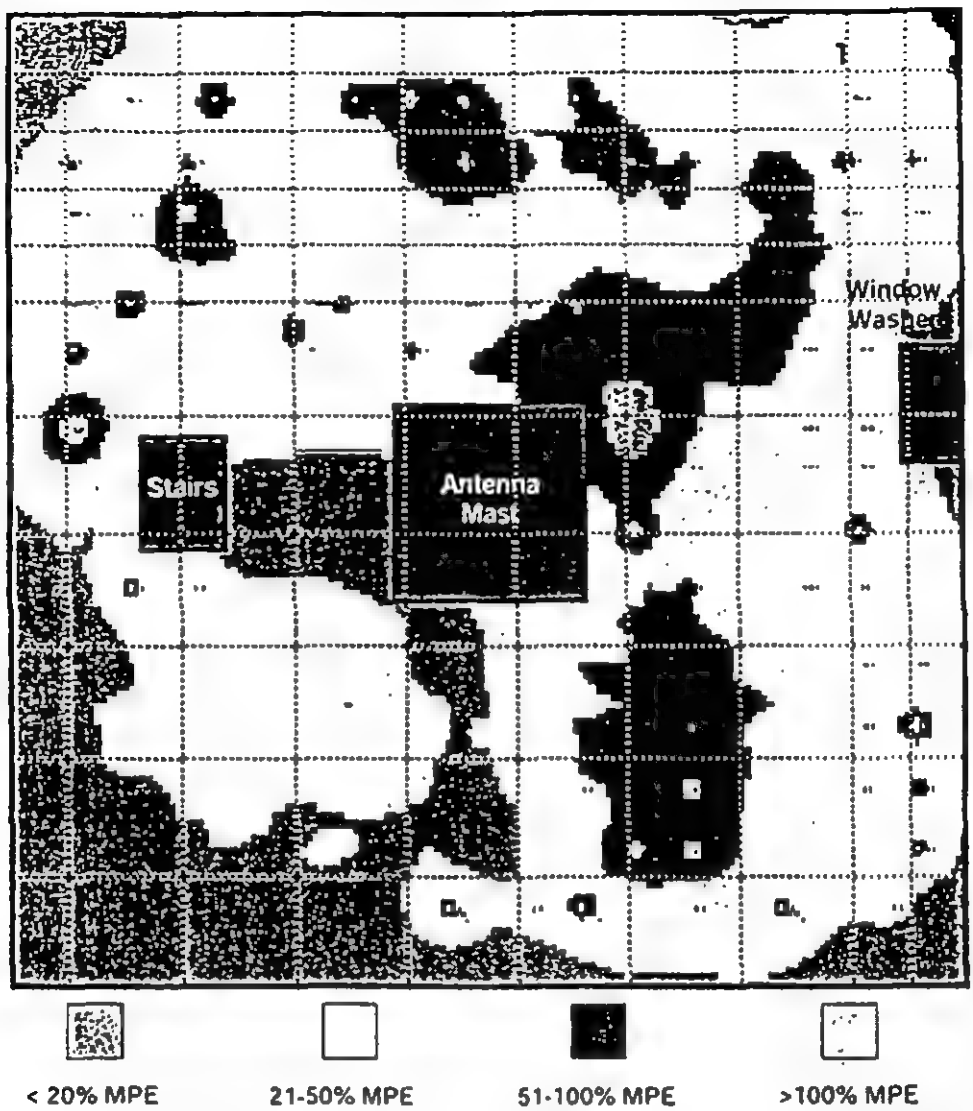
A 1999 reevaluation of RF fields from measured ambient fields of normal broadcasting operations with calculated contribution of all wireless telecommunications antennas (see footnote on page 10). Maximum field is 299.6% MPE.

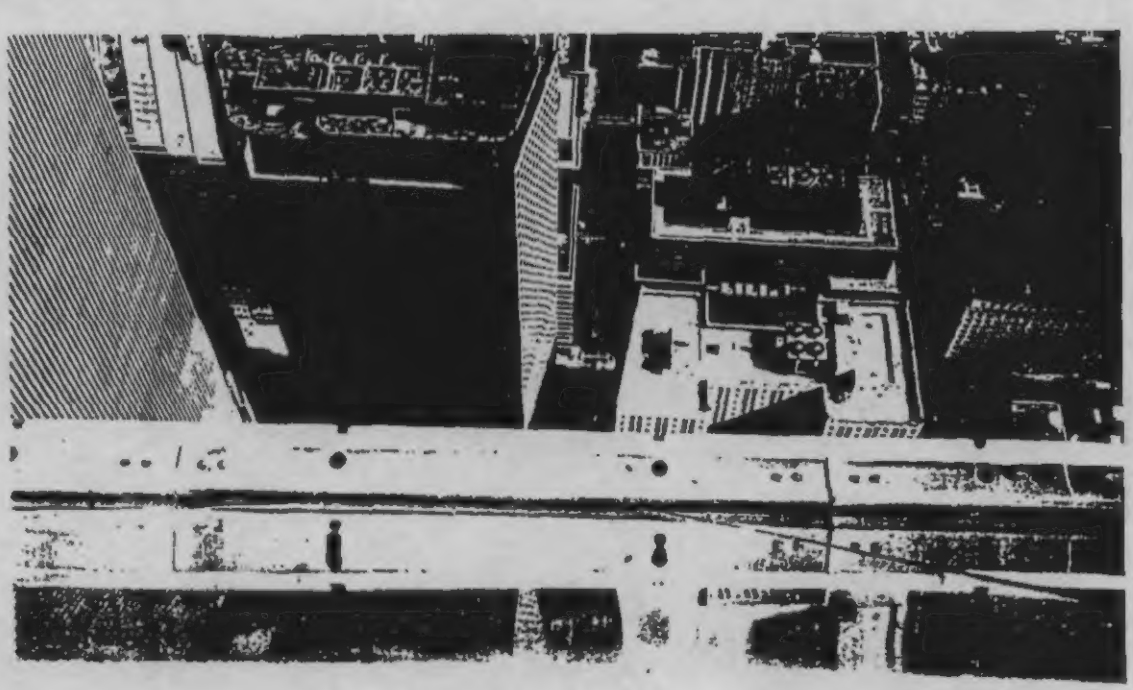
d. From the roof level it was noted that the steel framing that supports the sloped parapet panels is lightly rusted (Refer to photographs 13 and 14). The base of the steel framing is supported on a pedestal that comes up from the building structure below. Steel shim plates used between the steel framing the pedestal to adjust the level are severely rusted (Refer to photograph 15).
